Tip Of The WEEK

Frame Structure

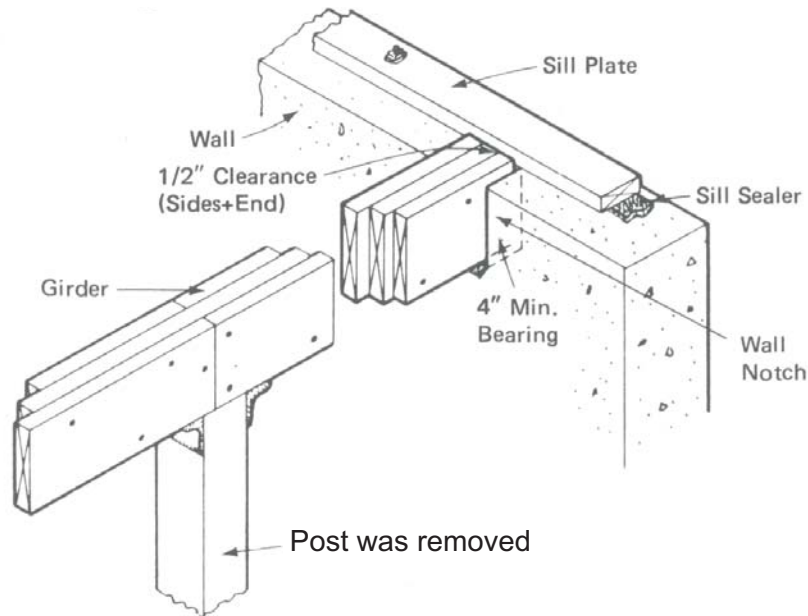
The main beam or girder is made up of 3 or 4 boards put together. The board ends are staggered for strength and supported by the posts below.

During a recent home inspection we found that a post had been removed. According to the seller "It was in the way". Even though there was no movement noted in the floors, walls, or roof line above, this represents a serious defect and potential for collapse.

The overall structure is made up of many components. When any part of the structure is compromised and the an inspector recommends repairs, shoring, or evaluation by a structural engineer...it should not be ignored.
