Fiberglass Tubs & Showers

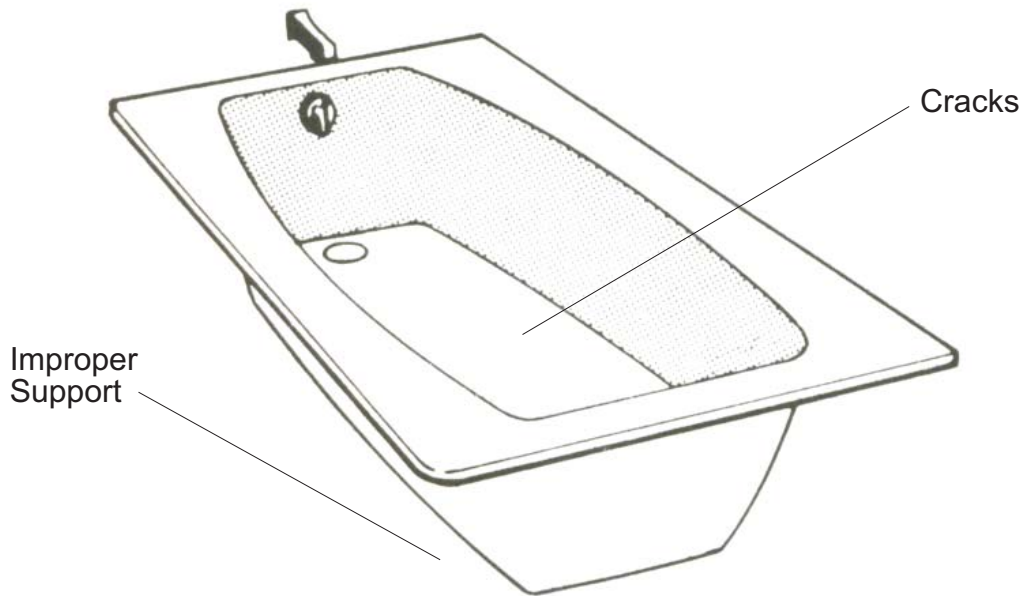
Improper support under the tub floor or shower pan allows for movement or flexing when weight is applied causing what appears to be hairline cracks. These minor cracks will open wider with the weight of someone standing in the tub and continue to grow over time.

Your home inspector pointed out hairline cracks in the fiberglass tub or shower and said something about improper support from underneath. You look at the cracks and decide they are too small to worry about - - two years later the tub or shower needs to be replaced ... what happened?

Don't be fooled by these seemingly small cracks in the tub floors or shower pans. Repairs maybe simple if caught early enough.
