Sub Slab Depressurization Inside Routing

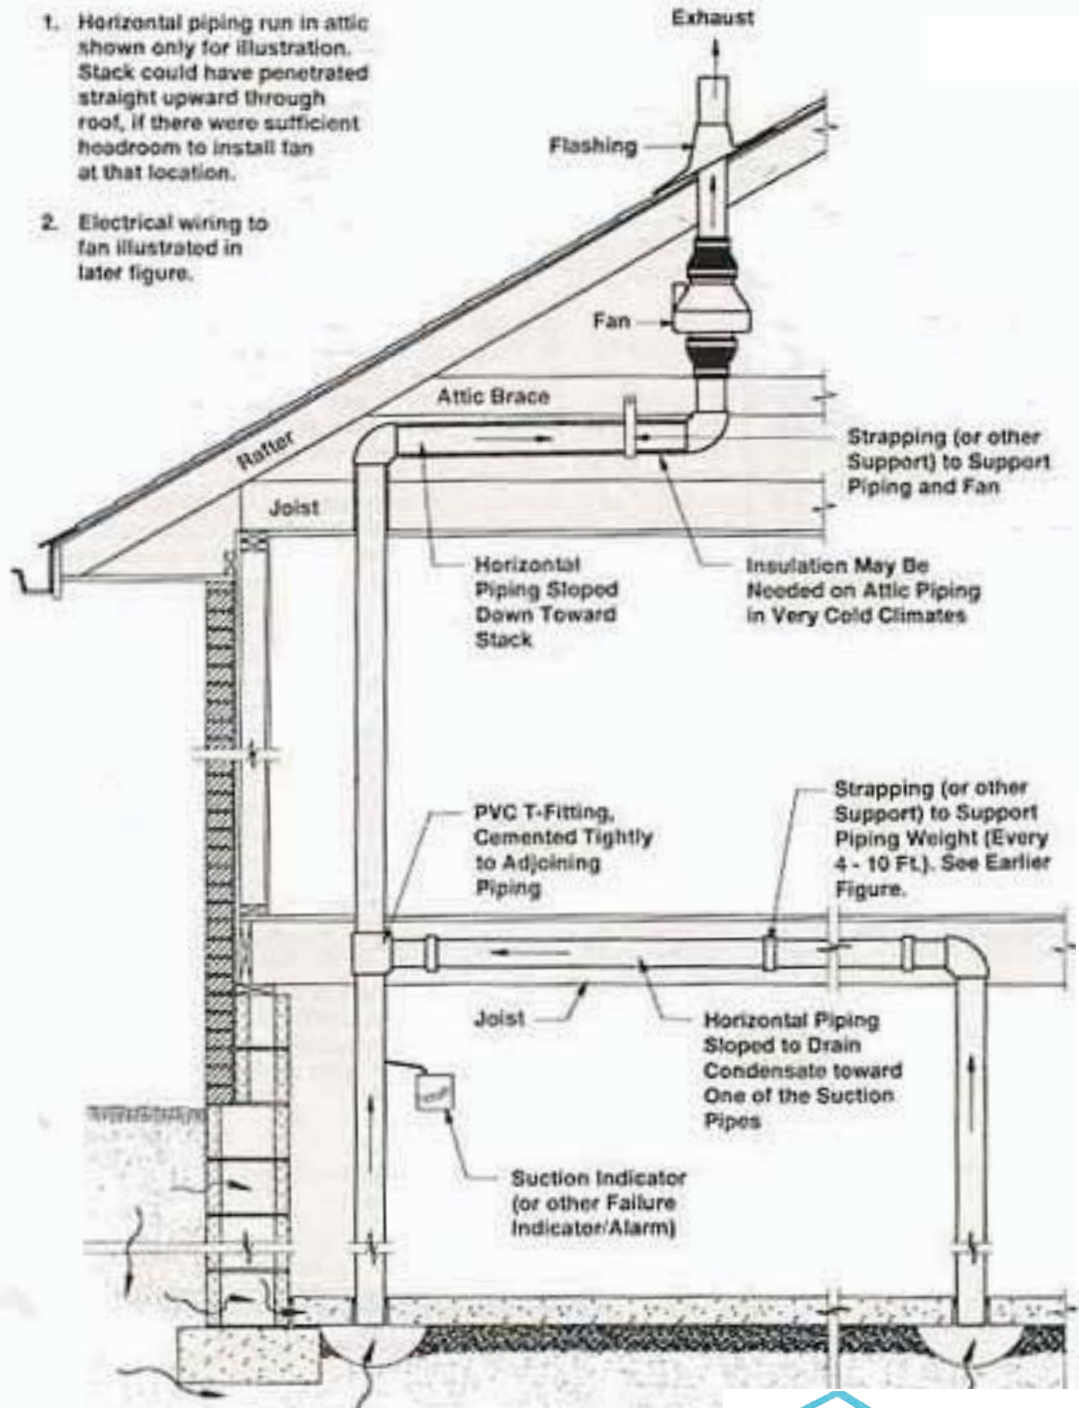
1. Horizontal piping run in attic shown only for illustration. Stack could have penetrated straight upward through roof, if there were sufficient headroom to install fan at that location.
2. Electrical wiring to fan illustrated in later figure.
