## Proper Bathroom Fan Venting

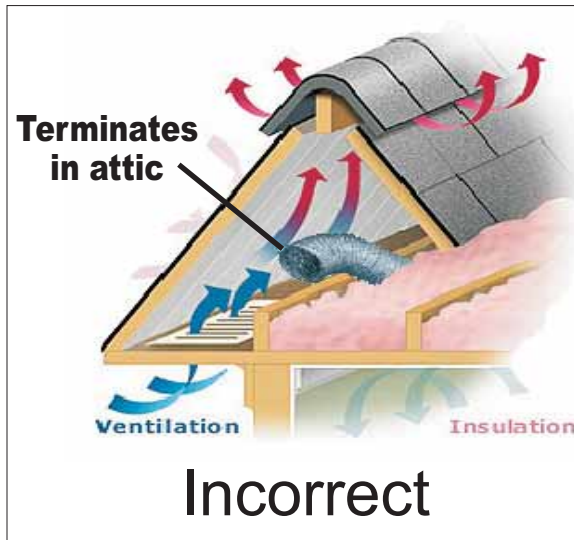
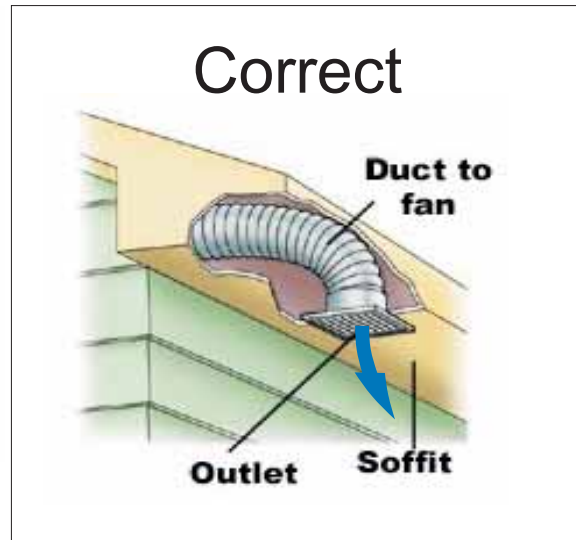
Bathroom vent pipes that do not have a dedicated vent opening to the exterior and terminates in the attic or soffit areas allow for the moist air to be forced back into the attic. The heavier moist air can interrupt the passive air flow and restrict ventilation. Excessive moisture from a bathroom fan vent provides ideal conditions for a very costly mold growth condition.

Excessive heat build up from the lack of proper ventilation again caused by this condition can allow crystalizing of the wood frame members causing them to become brittle over time. This represents a potential structural defect in the supporting frame members and costly repairs.

These conditions can be averted by properly terminating the bathroom fan vents.
